3. REPORT TITLE Hydrogen Stress Cracking of High Strength Steels			
4. DESCRIPTIVE NOTES (Type of report and, inclusive dates) Final Report			
5. AUTHOR(S) (First name, middle initial, last name) Walter Beck Edward J. Jankowsky Philip Fischer

HYDROGEN STRESS CRACKING OF HIGH STRENGTH STEELS

This report deals with hydrogen induced embrittlement and stress cracking of high strength steel parts. Selected mechanical methods involving the different types of test specimens for the measurement of hydrogen embrittlement or delayed failure, and relevant methods for the quantitative determination of hydrogen extracted from embrittlement susceptible specimens are presented. Embrittlement resulting from pickling and chemical milling are considered. In addition, case studies of failures are included dealing with electroplated steel aircraft components, weldments, the petroleum industry, parts installed in boilers, pressurized water reactors, pressurized hydrogenation units, and parts cathodically protected. Different techniques for restoring ductility or preventing delayed failure are also included.

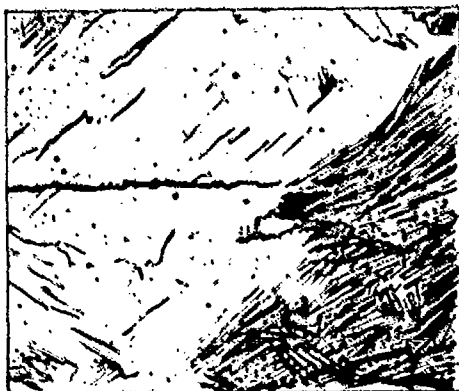
Fig. 8.1 - Transgranular hydrogen induced fissure in weld metal deposited from titania covered electrode without preheating (X500).

Crack susceptibility of a weld increases with the tensile strength of the steel. This tendency is also observed in the so-called "root cracking" which is frequently found in the first layer of a high strength steel weld of severe restraint [7]. It has been shown that the high hydrogen content of the weld metal is the most important factor promoting the formation of fissures [4]. Cracking may be either transgranular or intercolumnar. The transgranular fissures are the result of cleavage cracking induced by a combination of high hydrogen content and internal stresses. An example of such a fissure is shown in Fig. 8.1. The fissures are very narrow and sometimes are seen to pass through large spherical inclusions. They probably form below 200 C.

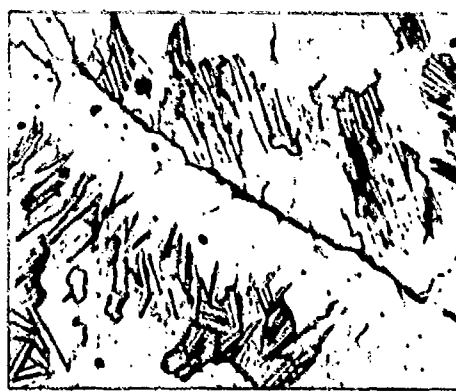
Fig. 8.2 - Intercolumnar hydrogen induced fissure in weld metal deposited from titania covered electrode without preheating (X500).

Intercolumnar fissures are also caused by the joint action of hydrogen and internal stresses, but they appear to be associated with non-metallic particles lying between the columnar crystals. An example of such a fissure is given in Fig. 8.2.
